REPORT ON FUEL-PLATE MELTING

AT THE OAK RIDGE RESEARCH REACTOR JULY 1, 1963

ORNL-TM-627

OPERATIONS DIVISION

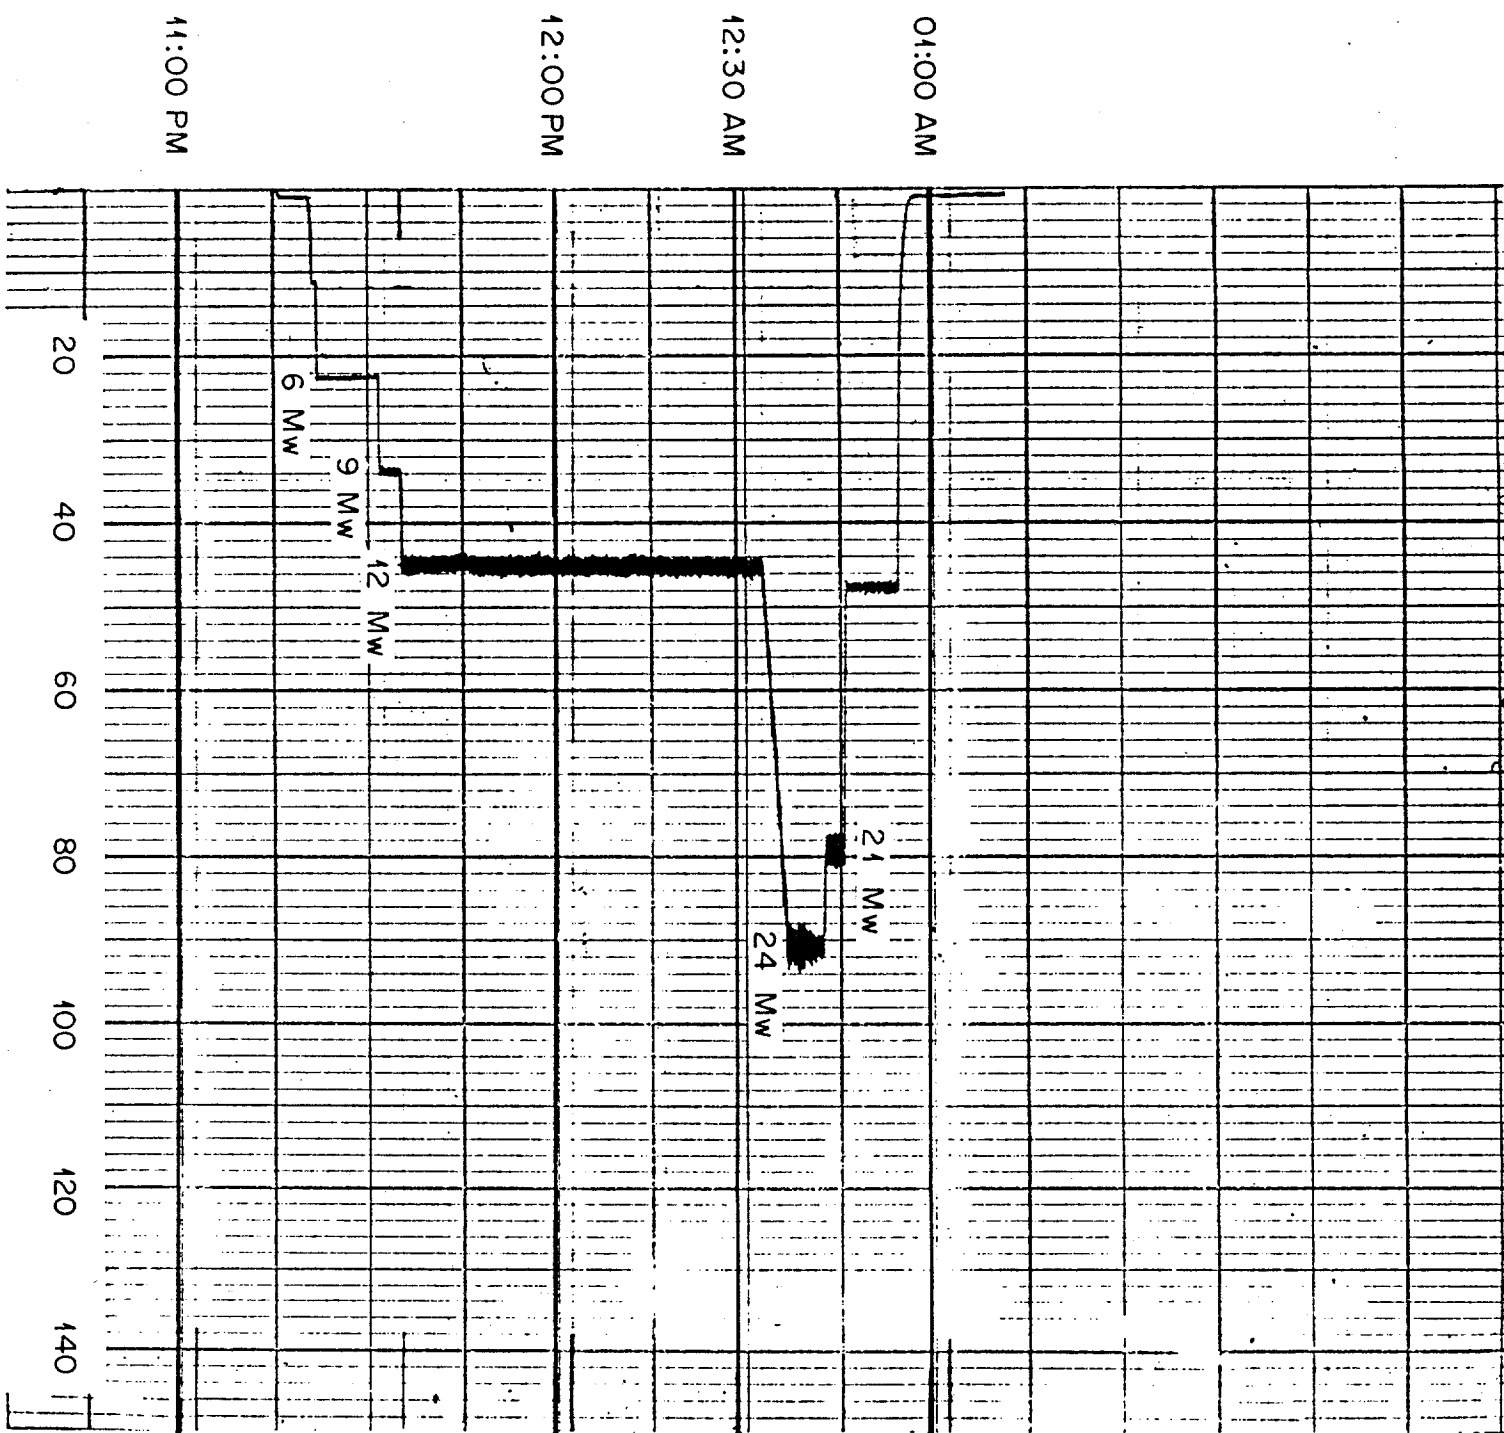
It is worth noticing that the noise amplitude at 24 Mw, as shown by the two safety channel and the gamma chamber charts, remained constant during the first three minutes of the run and then decreased steadily. The various radioactivity monitors (see Figure 4) also indicate that the activity was released during the first two or three minutes of the 24-Mw run. Subsequent inspection of the fuel plates of the damaged element showed that only one plate melted, and it is possible that this occurred in a short time following which the melting stopped and the boiling which caused noise in the instruments became less severe.

NO. 3 SAFETY CHANNEL

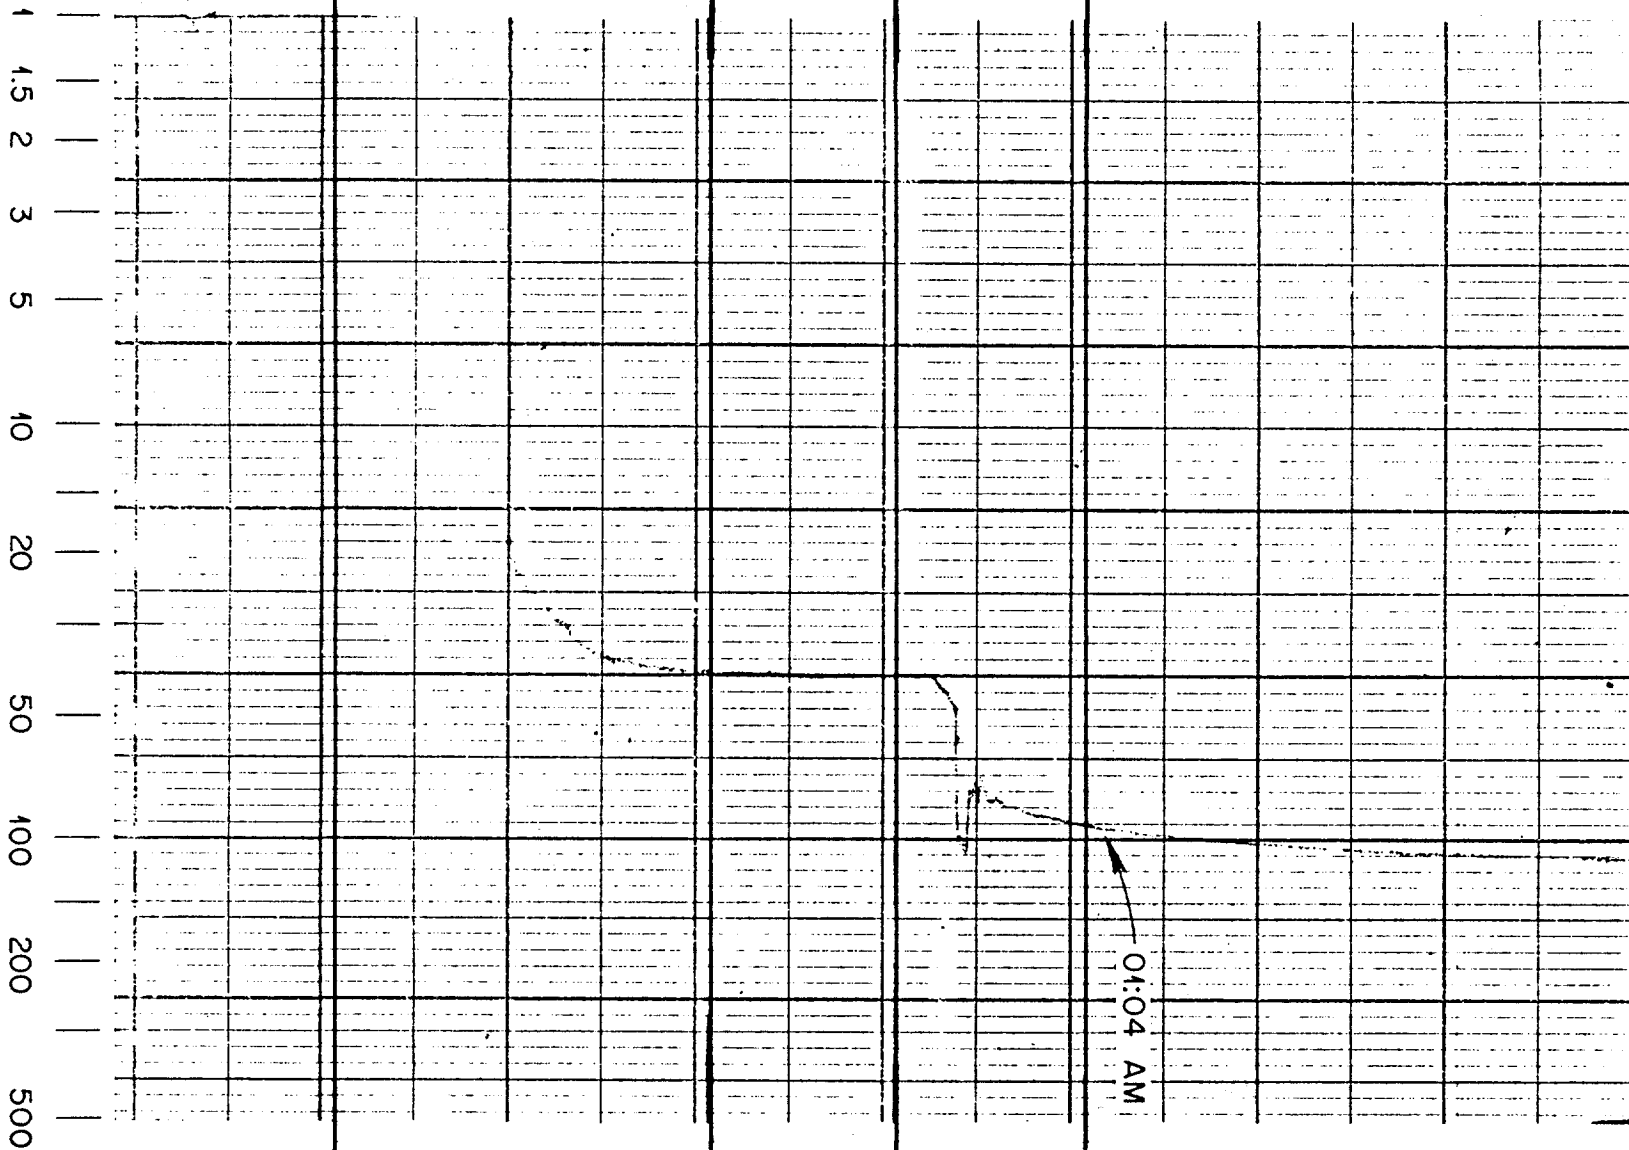
REACTOR WATER ACTIVITY

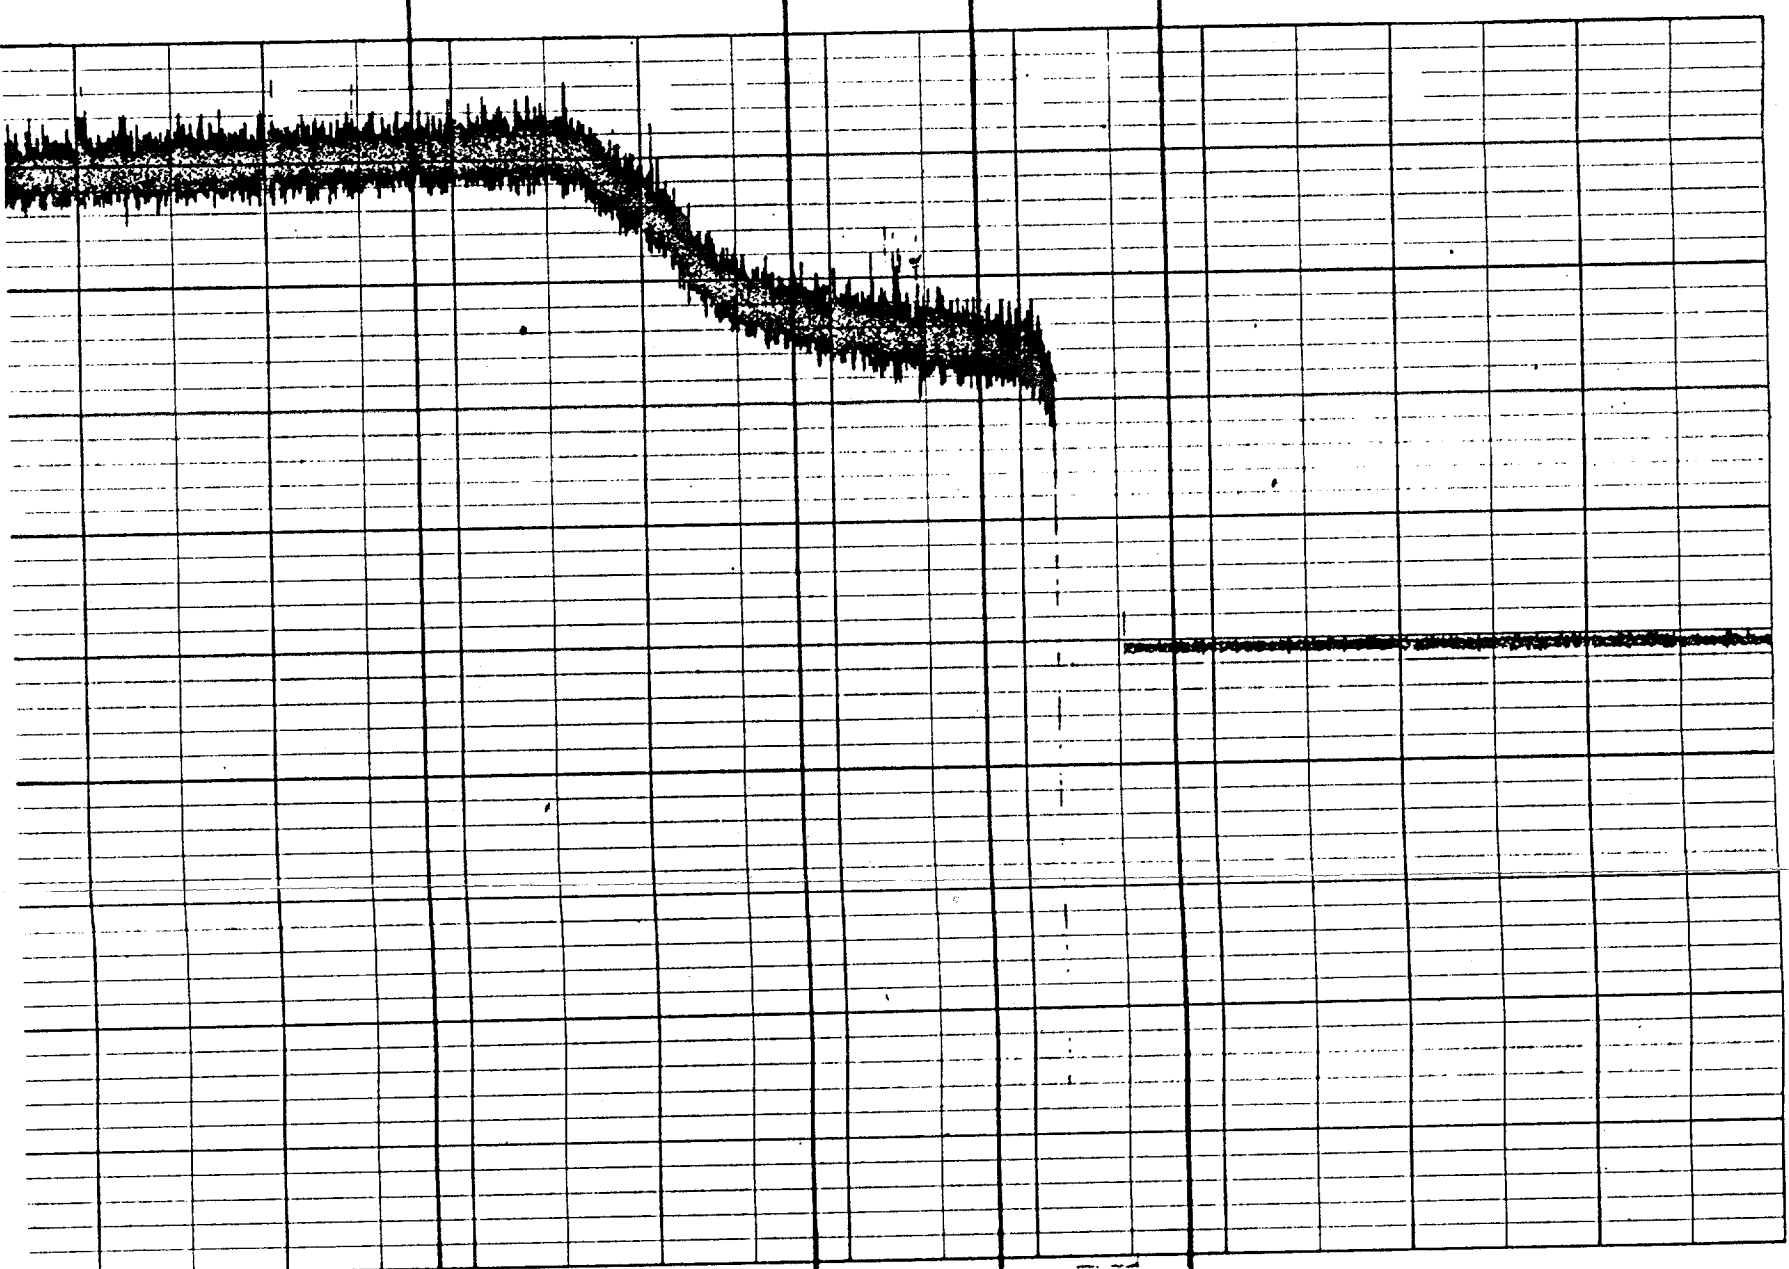
REACTOR SECONDARY WATER ACTIVITY
(SHINE FROM PRIMARY HEAT EXCHANGERS)

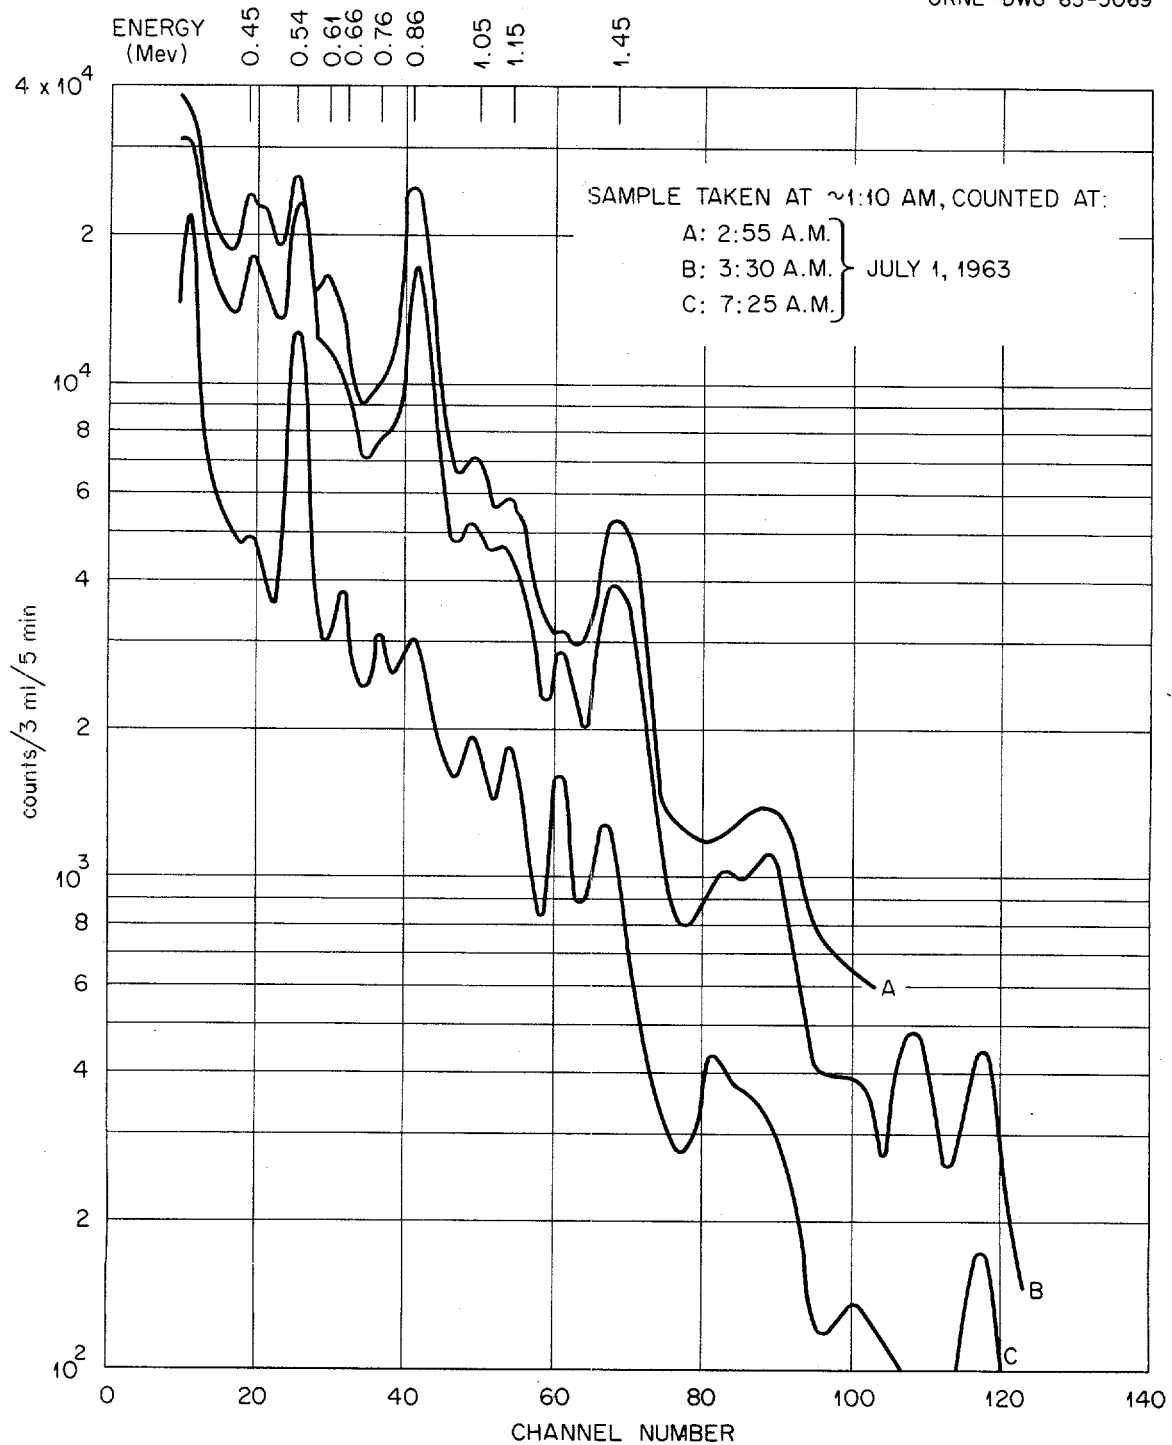
UNCLASSIFIED
ORNL-DWG 63-3069

Preliminary estimates, based on the gross β - γ activity of a sample of the reactor water system taken at 1:10 AM and an estimated counter efficiency and geometry factor, indicate a total fission-product inventory of the order of 1000 curies in the coolant system one-half hour after the release. Analyses of reactor water system samples (Figures 5 and 6) on a gamma spectrometer indicated that the principal contaminants were 54-min ^{134}I , 21-hr ^{133}I , 6.7-hr ^{135}I , 32-min ^{138}Cs , and 2.8-hr ^{88}Kr . This, together with other observations subsequently discussed, indicates rather conclusively that only volatile fission products were released from the fuel element into the water in significant quantities. Radiation levels at the south reactor demineralizer anion column (on stream at the time of the release) reached ~ 20 r/hr (as compared to levels of ~ 100 - 200 mr/hr normally experienced at 30 Mw) further indicating that a significant portion of the contamination of the water system could be attributed to iodines. The recorded response of a radiation detector seeing "shine" from the column indicated that this radiation level was probably attained within 10 to 30 minutes after the release. Radiation levels at the pool demineralizer anion column reached ~ 400 mr/hr. This is of the order of 10 to 20 times the level normally encountered at 30 Mw. No significant increases in the radiation levels at the various demineralizer cation columns were observed.

Fig. 5. γ -Spectra of a Reactor Water Sample

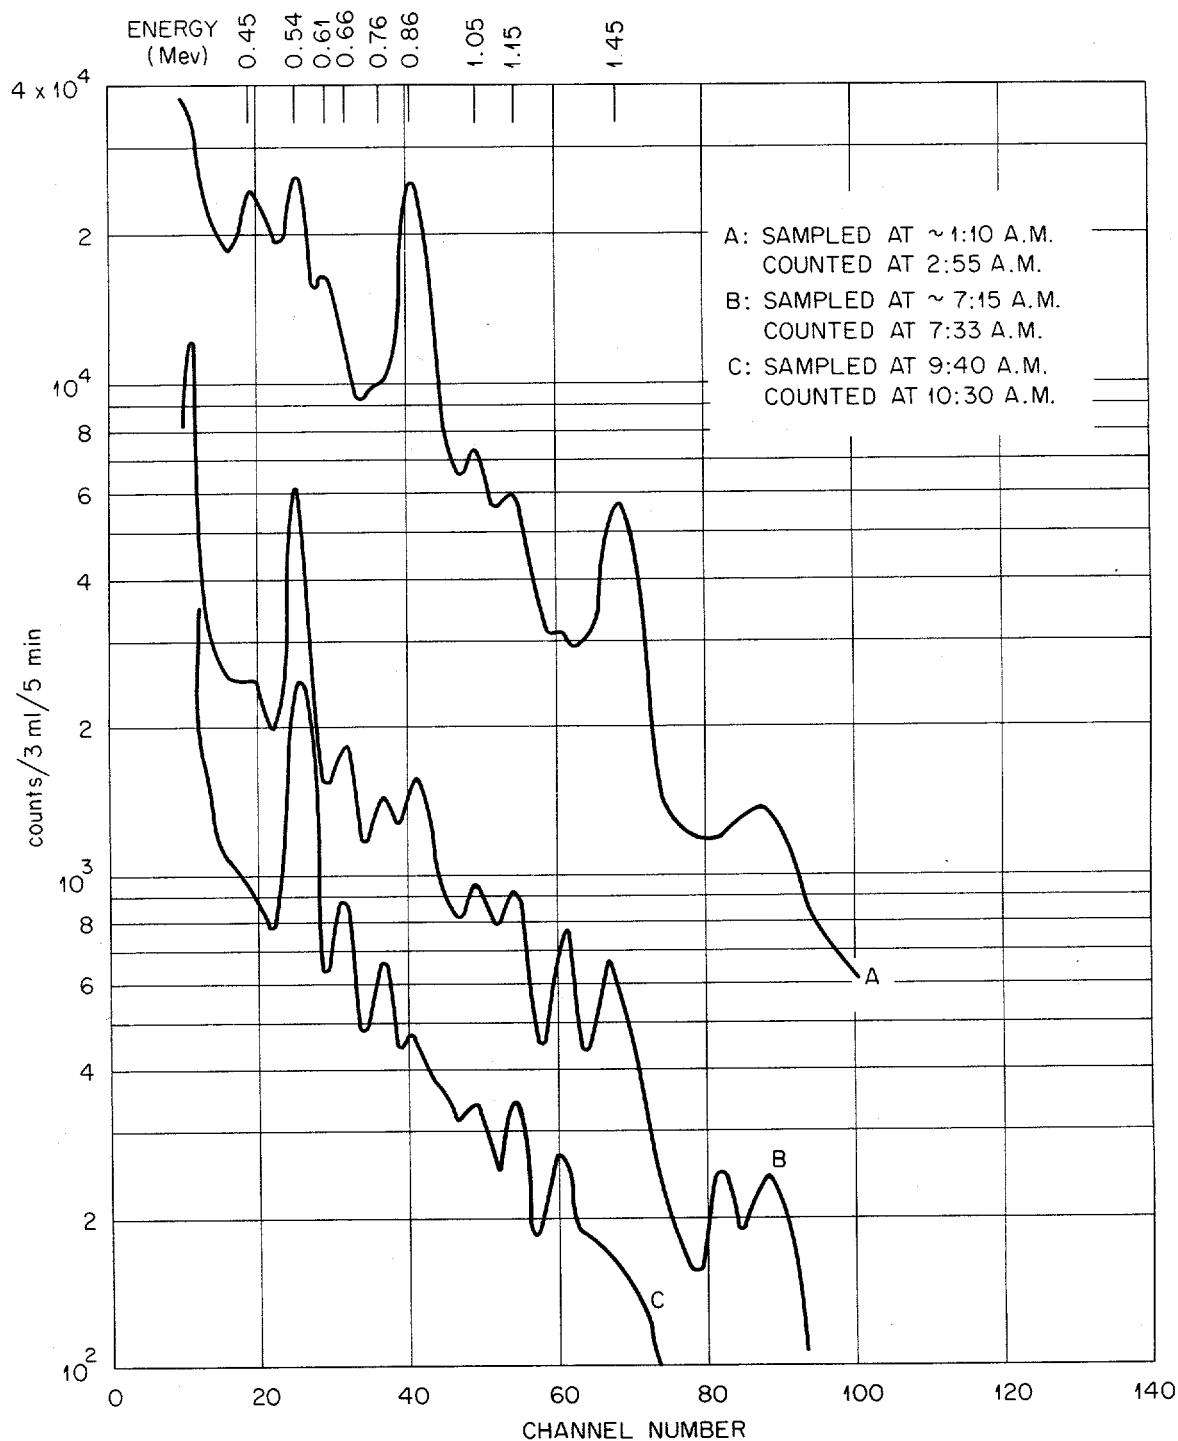
UNCLASSIFIED
ORNL-DWG 63-3070

Fig. 6. γ -Spectra of 3 Different Reactor Water Samples

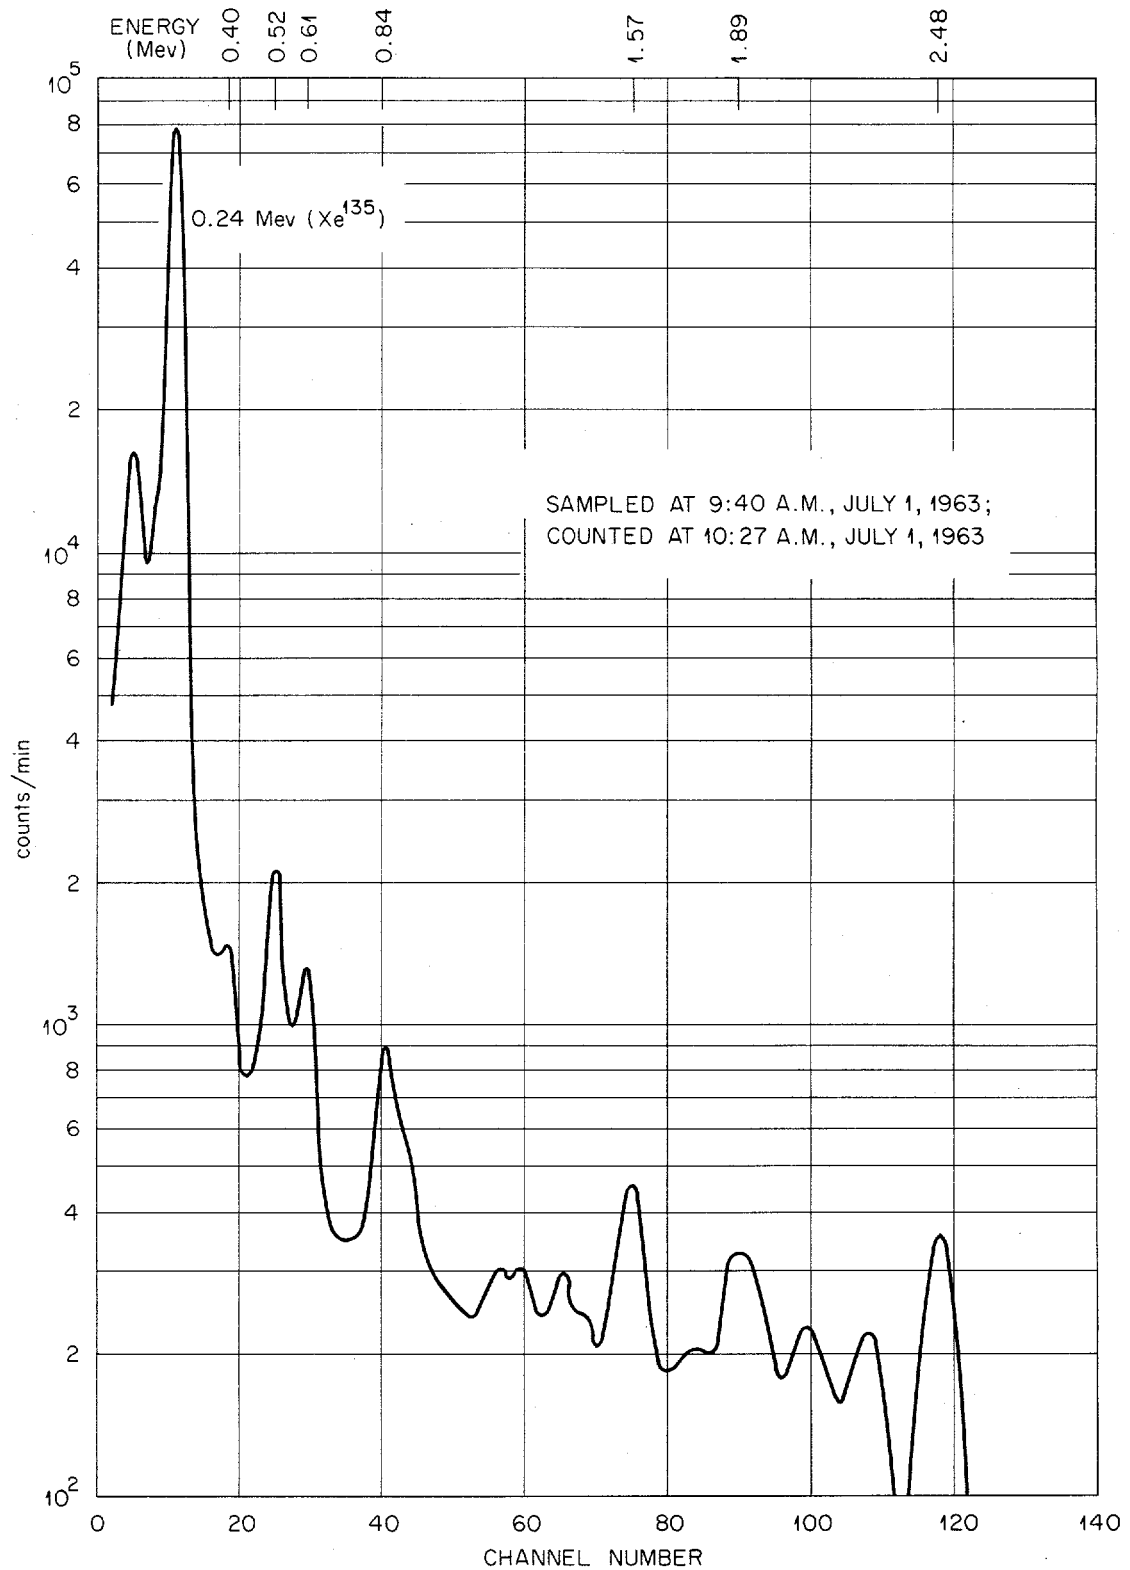
UNCLASSIFIED
ORNL-DWG 63-3072

An analysis, on a gamma spectrometer, of the gases boiled from a 500-cc sample of the reactor system water taken at 9:40 AM (Figure 9) indicates the presence of ^{135}Xe in addition to ^{138}Xe and ^{88}Kr . The apparent preponderance of ^{135}Xe in this sample can probably be attributed to the fact that when the sample was taken most of the ^{88}Kr and ^{138}Xe had decayed.

Fig. 9. γ -Spectrum of Gas from 500 cc of Reactor System Water

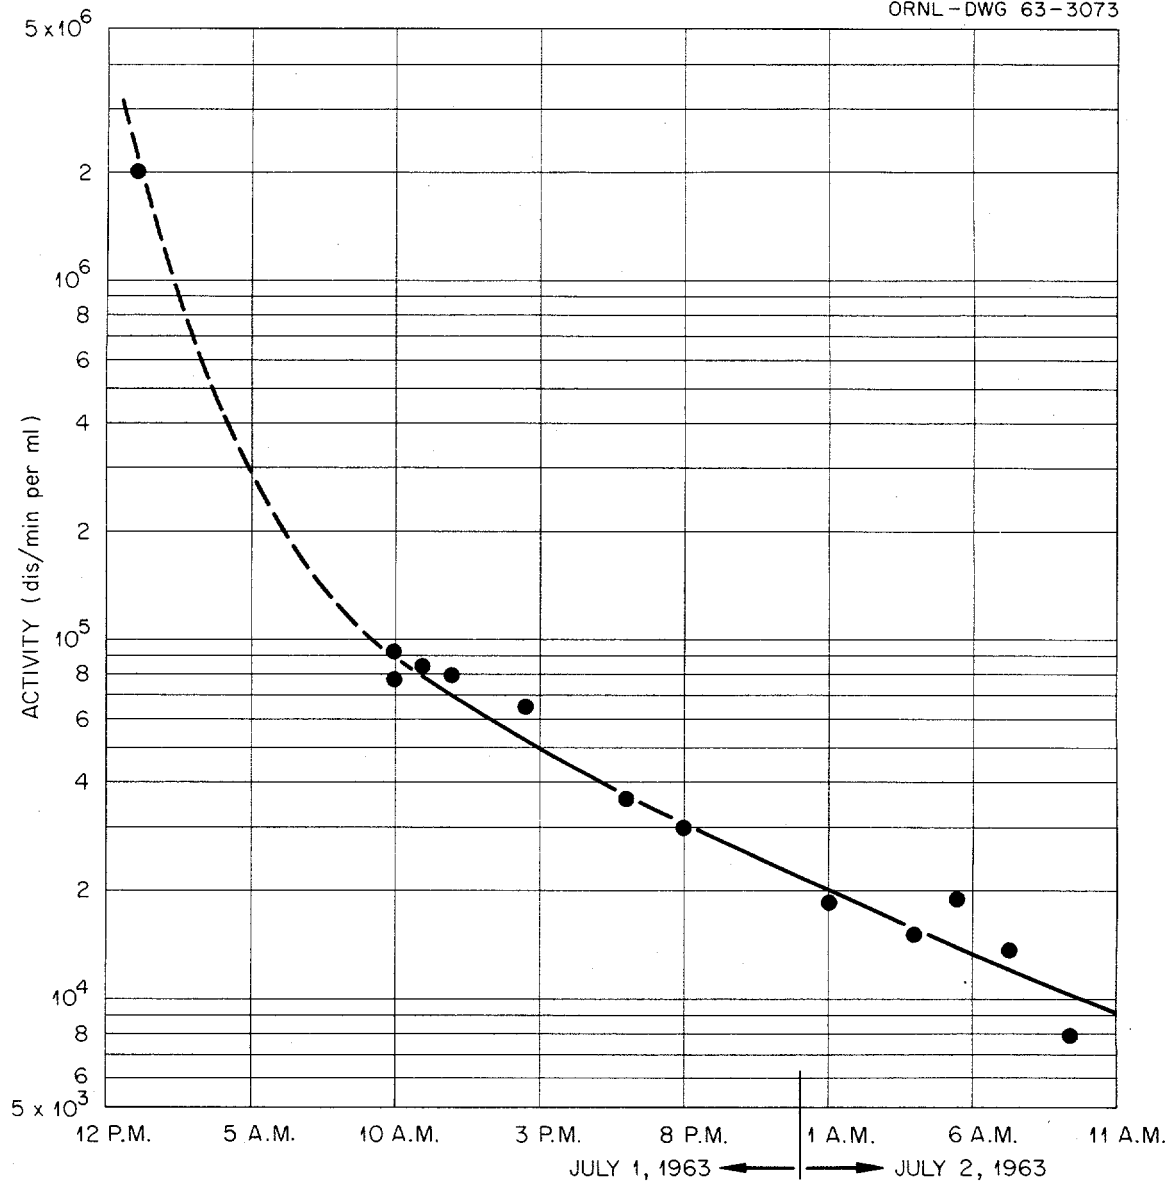
UNCLASSIFIED
ORNL-DWG 63-3073

Figure 10 shows the decay of the gross β - γ contaminant concentration in the reactor water system as a function of time after the release. After four months, the gross gamma radioactivity level in the reactor primary system was about 70% greater than that prior to the incident. Presumably, this is due to small amounts of uranium released from the melted fuel which remain in, or near, the core in a region of high neutron flux. The major activities observed in the reactor water system are listed in Table 2. The radioactivities present in the system prior to July 1, 1963, are listed for comparison.

Fig. 10. Gross γ - β Activity Level; ORR Reactor Primary Coolant System

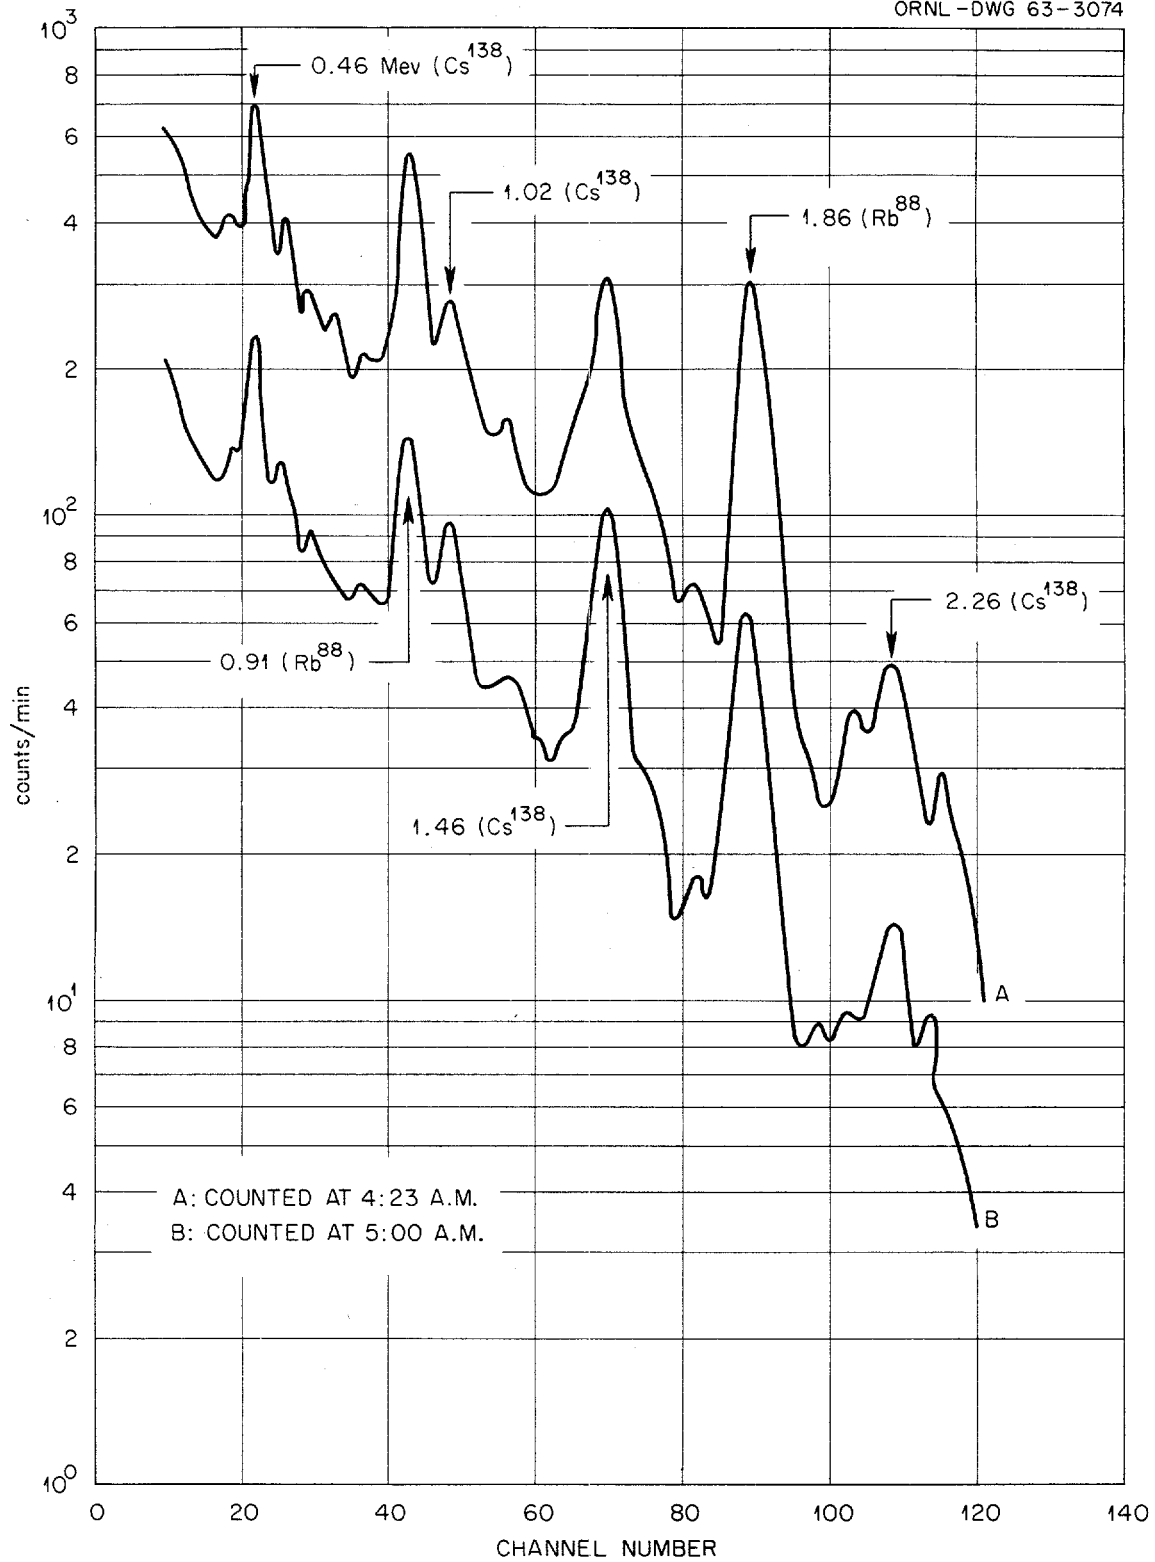
UNCLASSIFIED
ORNL-DWG 63-3074

Fig. 11. γ -Spectra of Filter from Air Monitor

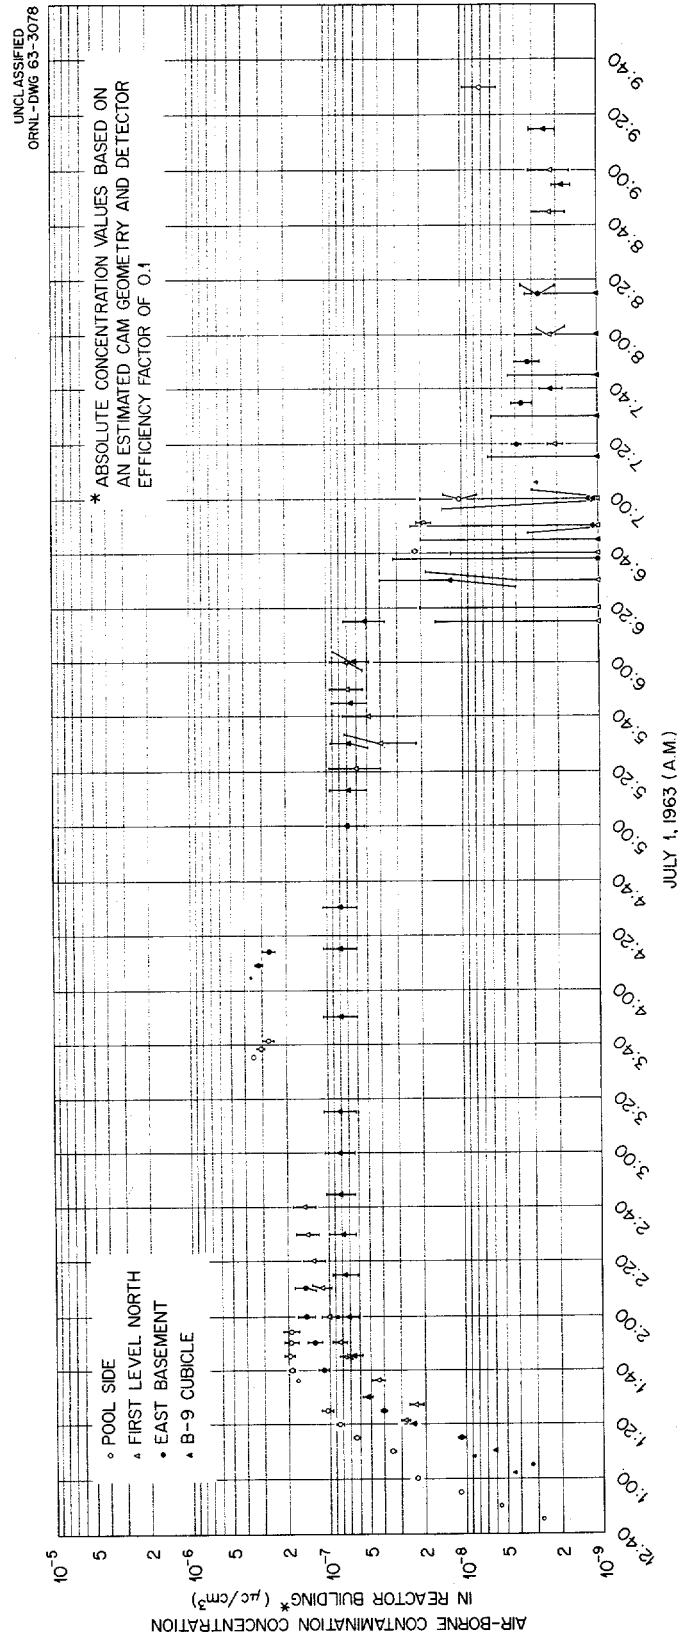
Some fraction of the noble gases released into the reactor coolant system diffused to the building atmosphere (principally as ^{138}Xe and ^{88}Kr) through the pool-reactor system equalizer to the pool and from the pool to the building atmosphere. Decay of these gases, subsequent to their release from the water system, resulted in air-borne contamination in the building primarily by ^{138}Cs and ^{88}Rb (identified by gamma-spectrometer analysis of the air monitor filter (Figure 11). Peak air concentration of these contaminants is estimated at 10^{-6} to 10^{-7} $\mu\text{c/cc}$.¹ Estimates of the relative buildup of these isotopes in the building are given in Figure 12. The uncertainty in the levels indicated in the figure is due entirely to the uncertainty in the relative proportions of ^{138}Cs and ^{88}Rb present. Indicated upper limits are based on the assumption of 100% ^{88}Rb and indicated lower limits are based on the assumption of 100% ^{138}Cs .

Fig. 12. Air-Borne Contamination Concentration in Reactor Building

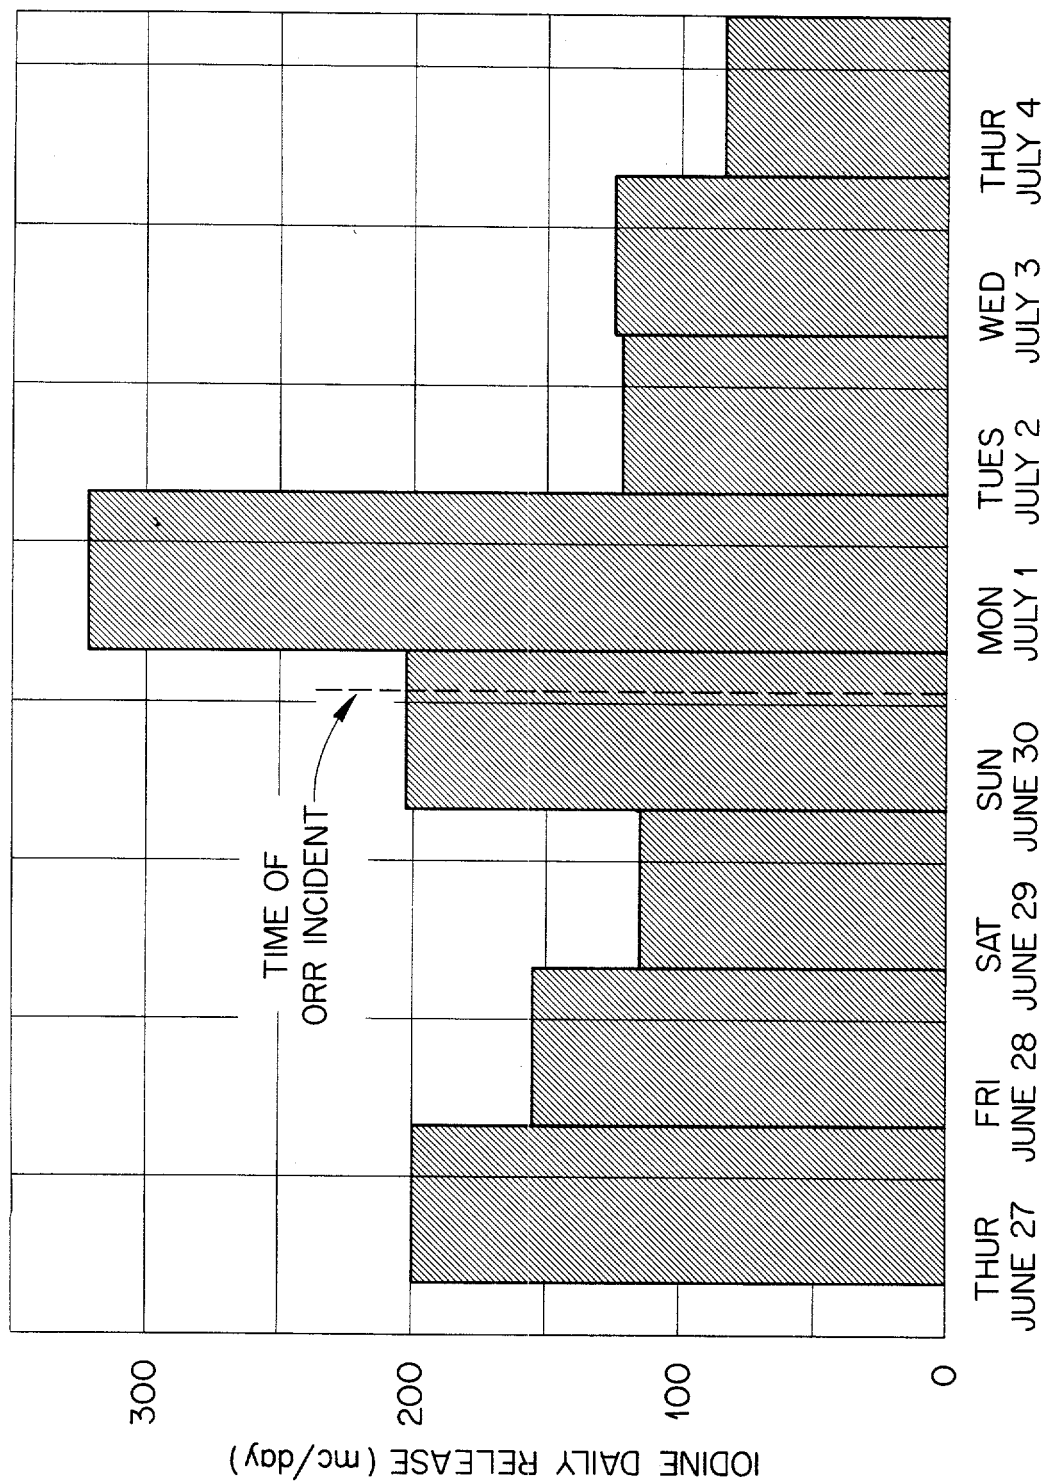
Figure 13 shows the amount of iodine released per day during the week surrounding the incident. The stack monitoring instruments indicated that approximately 150 mc of radioiodine were released through the stack as a result of the melting of the fuel plate. Most of the radioiodine released in the water system was undoubtedly removed by the demineralizers and by radioactive decay, although a small portion was probably removed by the caustic scrubber and filters in the off-gas system.

Fig. 13. Daily Iodine Release Through 3039 Stack
